Investigating Mesh Erosion in Pelvic Floor Repair

Report

18 May 2011

FPM-11-0024-R_C

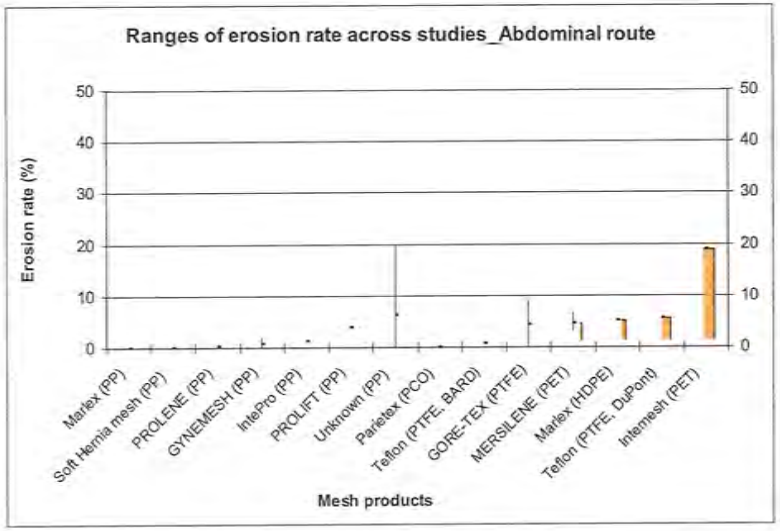
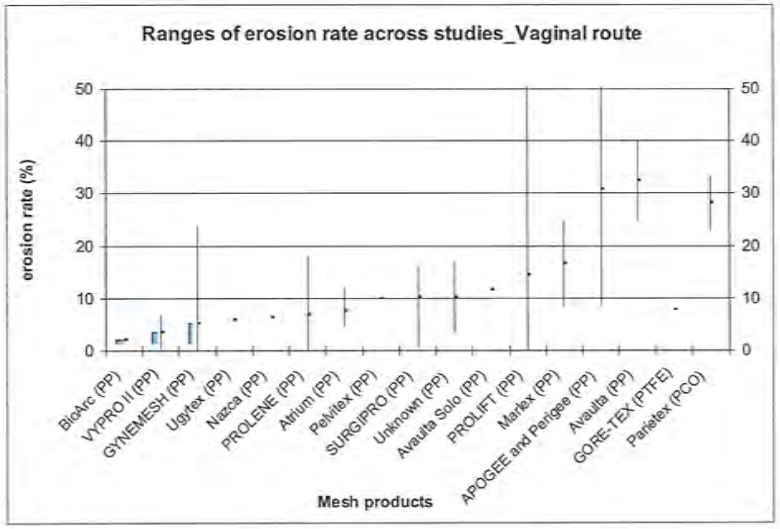
Vaginal surgery has a higher risk of mesh erosion than abdominal surgery

Analysis of erosion rate across the body literature by vaginal and abdominal surgery by brand of mesh used (all procedures, all study types, all patient numbers and groups, all follow up types where PA had the data available)

A high level meta-analysis of the data in the J&J literature search[1] was conducted and erosion rates from all studies therein were tabulated. Trans-vaginal implantation appears to show higher erosion rates than trans-abdominal surgery

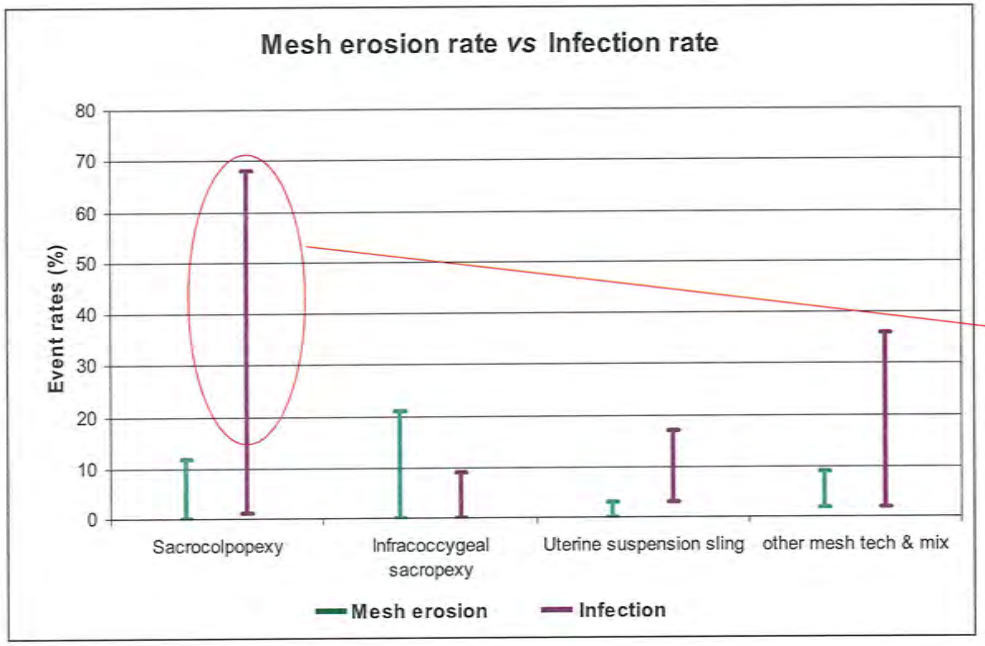
The Glazner[1] review also shows that trans vaginal surgery is more likely to lead to erosion than abdominal surgery although infection rates are higher

The infection rates show more infections in trans-abdominal than trans-vaginal surgery, which is counter intuitive.

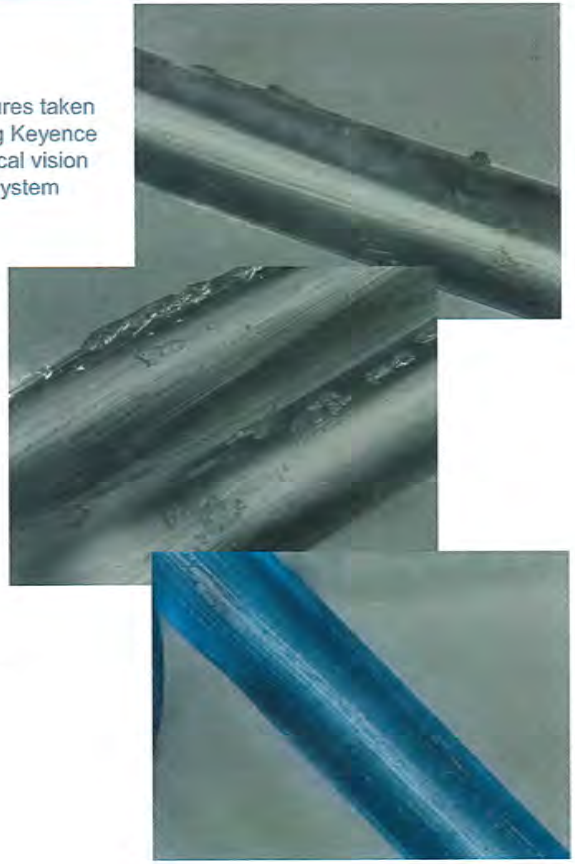
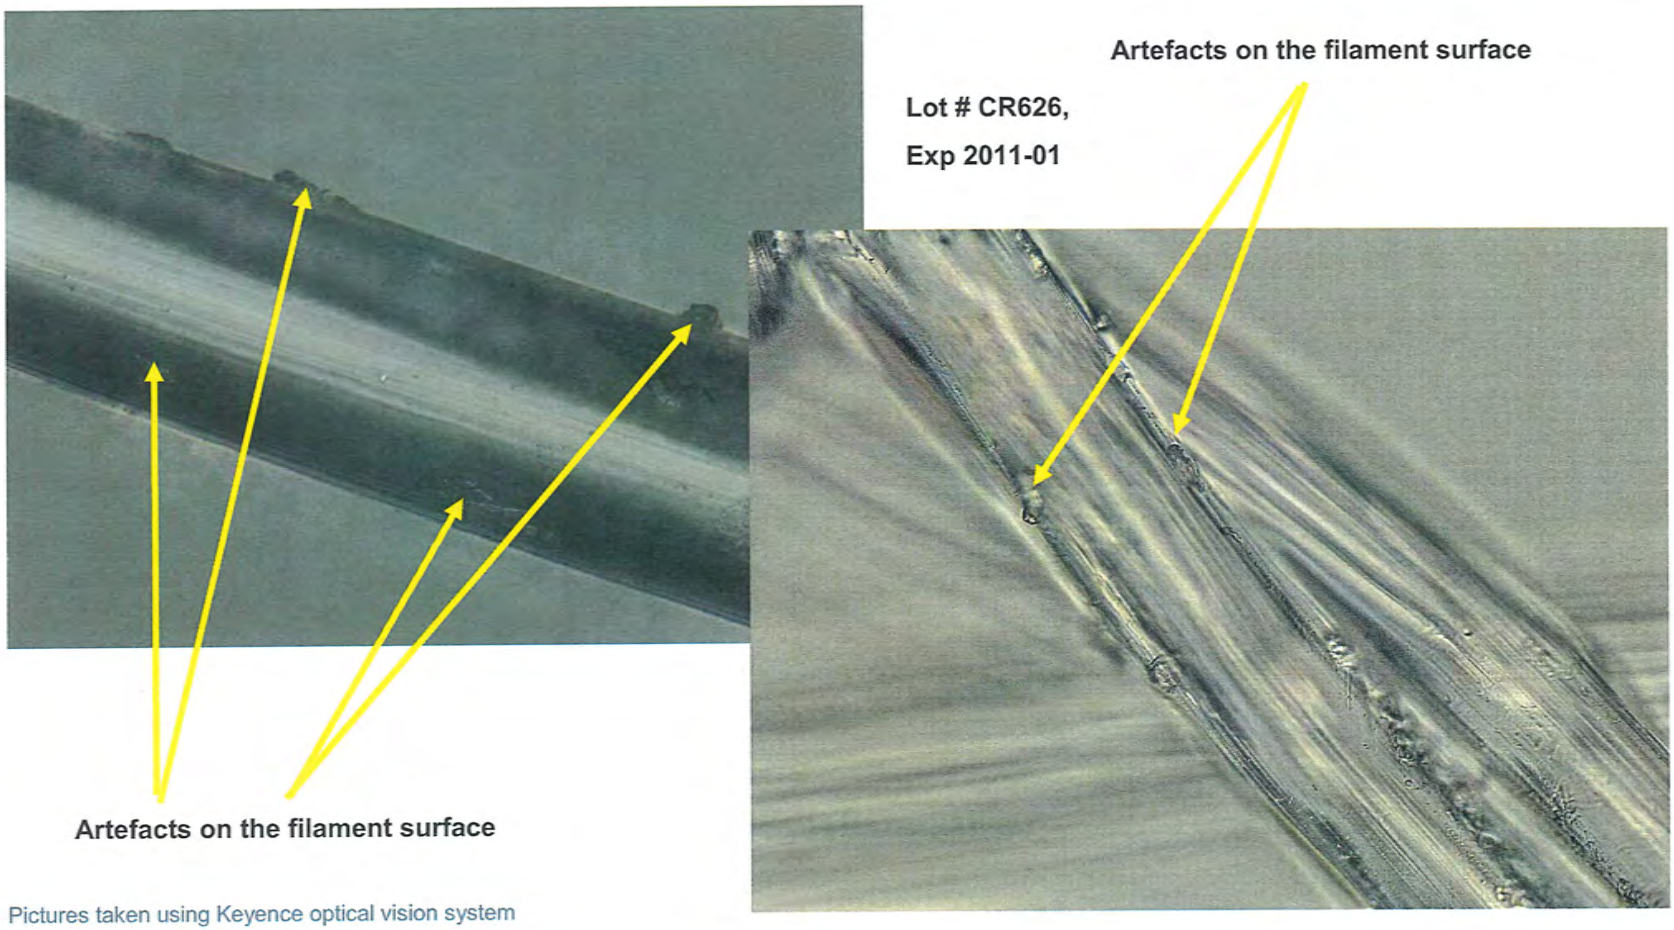
- However:
  - High magnification pictures of filaments within a random sample of finished products show a number of surface effects (note also images on the following slides)

- It is not certain where in the production process these artefacts are generated; perhaps extrusion/winding and scouring
  - We cannot discount the possibility that this type of artefact contributes to the potential for undesirable clinical outcomes

Gynemesh PS filaments exhibit artefacts on the surface

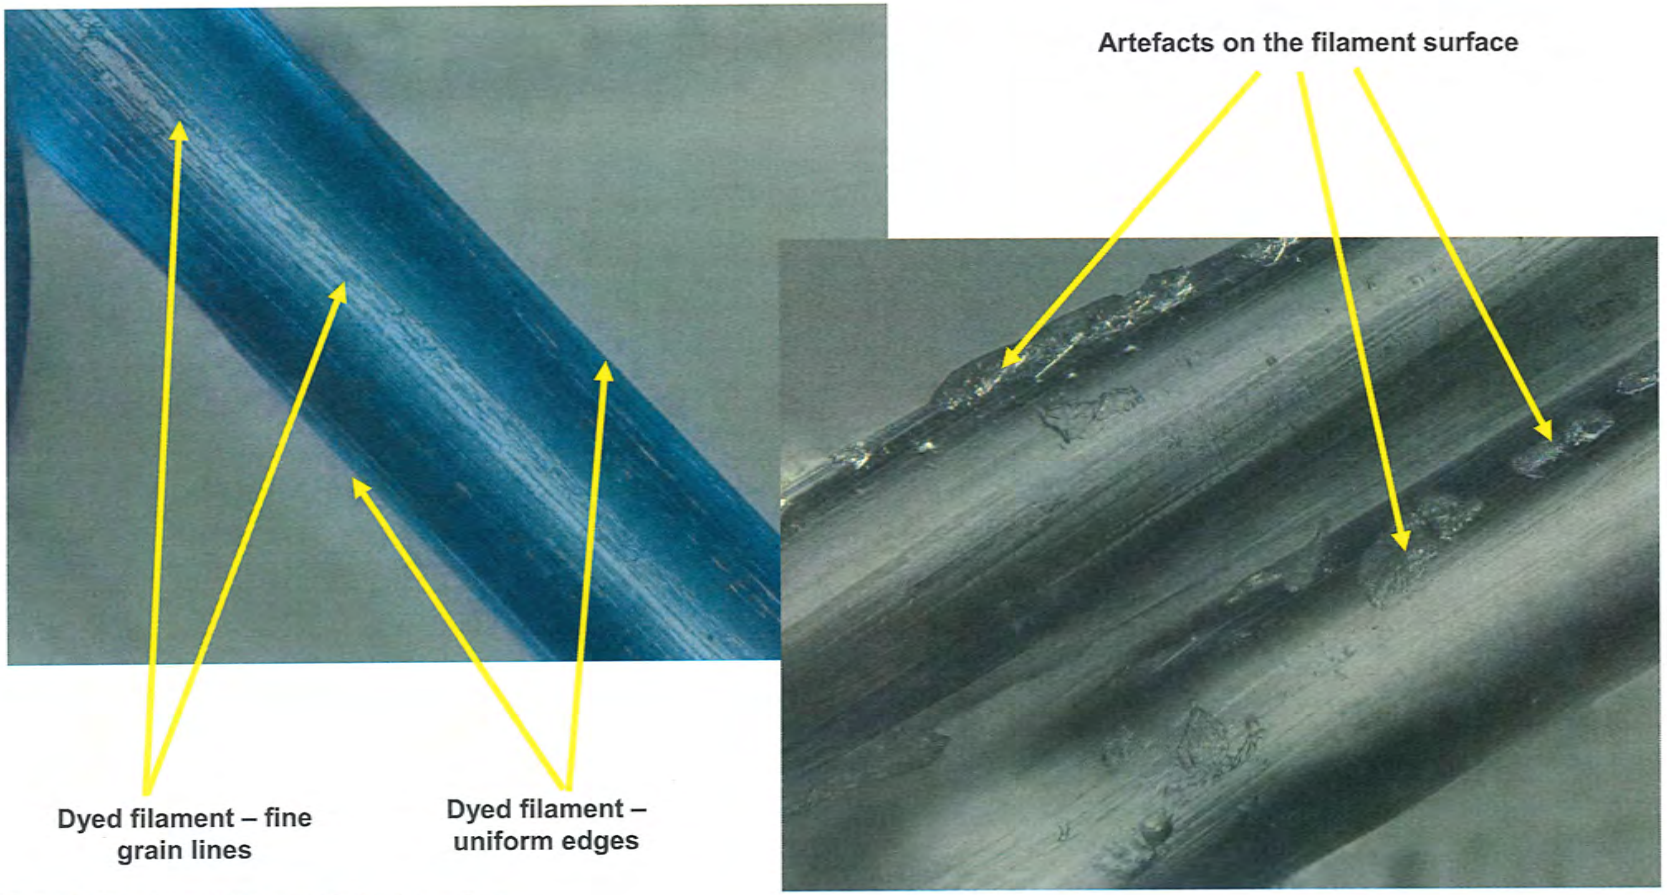
Gynemesh PS filaments exhibit artefacts on the surface (continued)

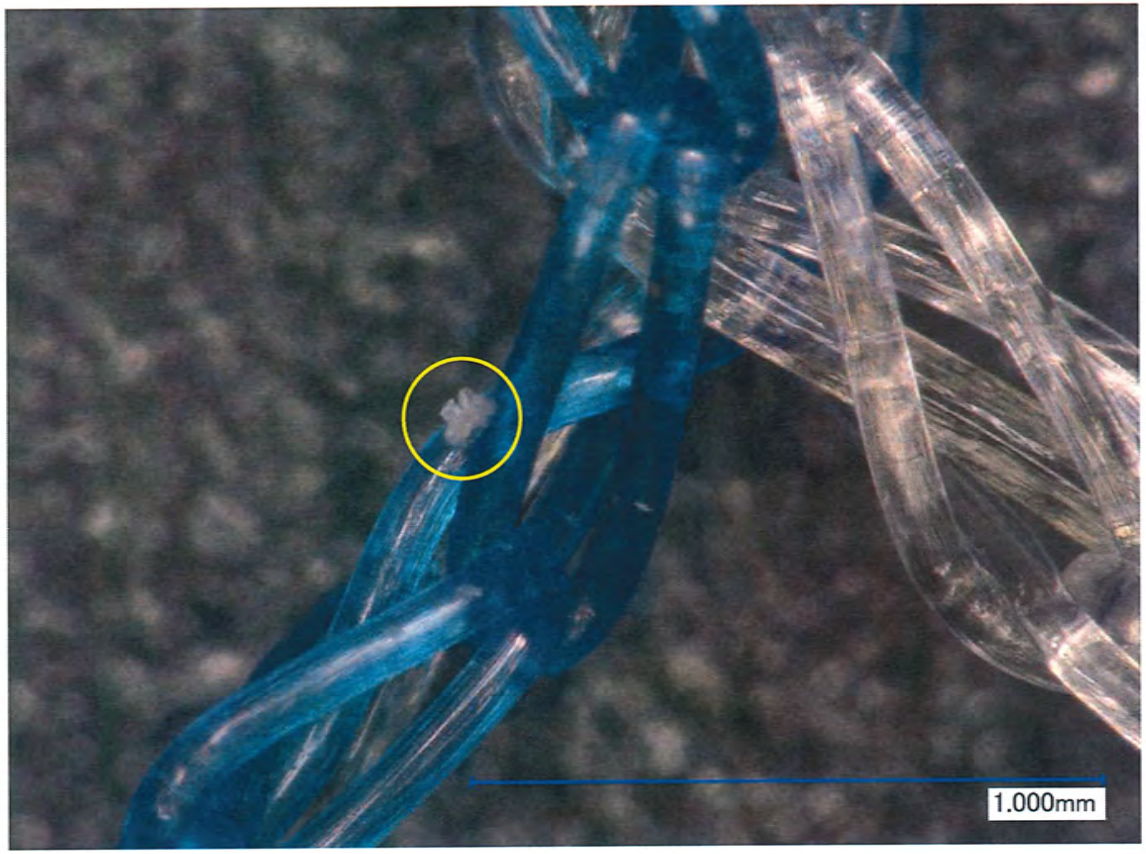
Gynemesh M (Ultrapro)

Prolift +M filaments exhibit artefacts on the surface

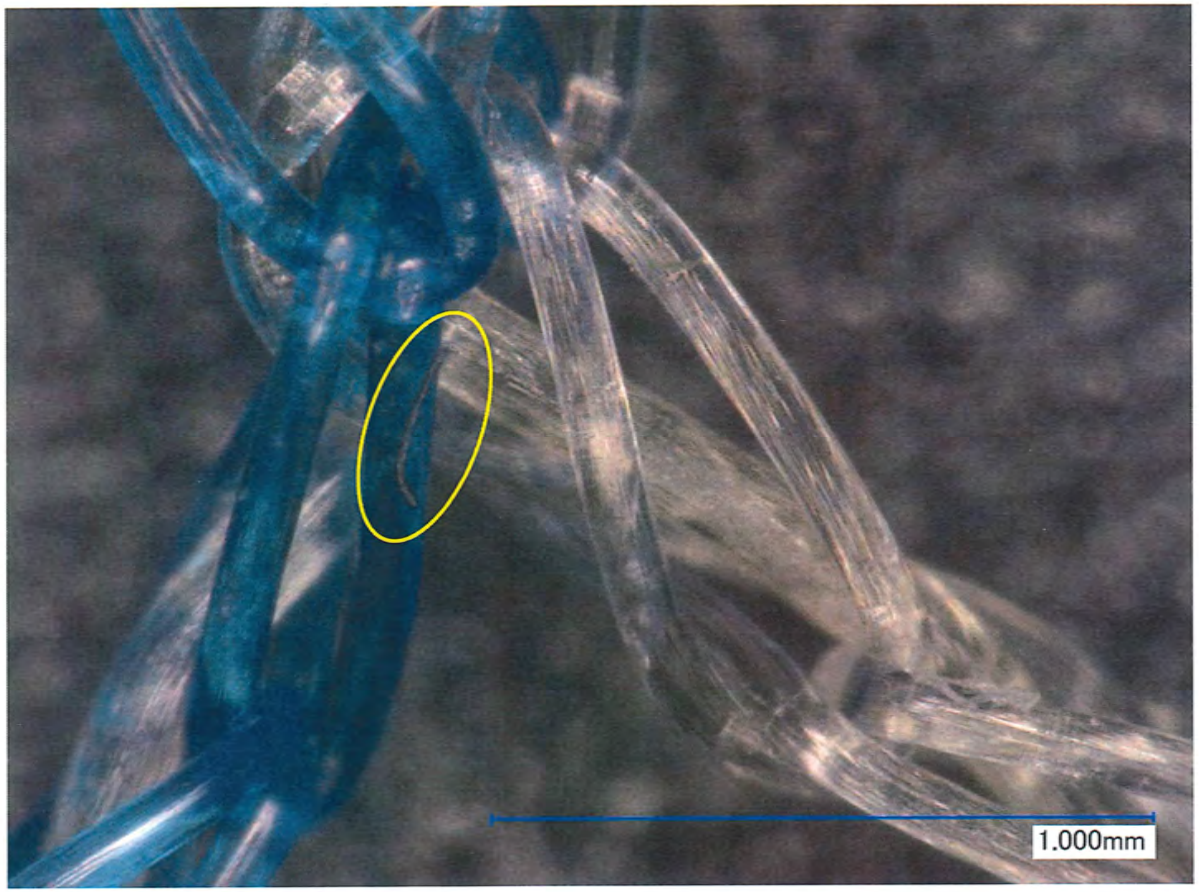
Prolift +M filaments exhibit artefacts on the surface (continued)

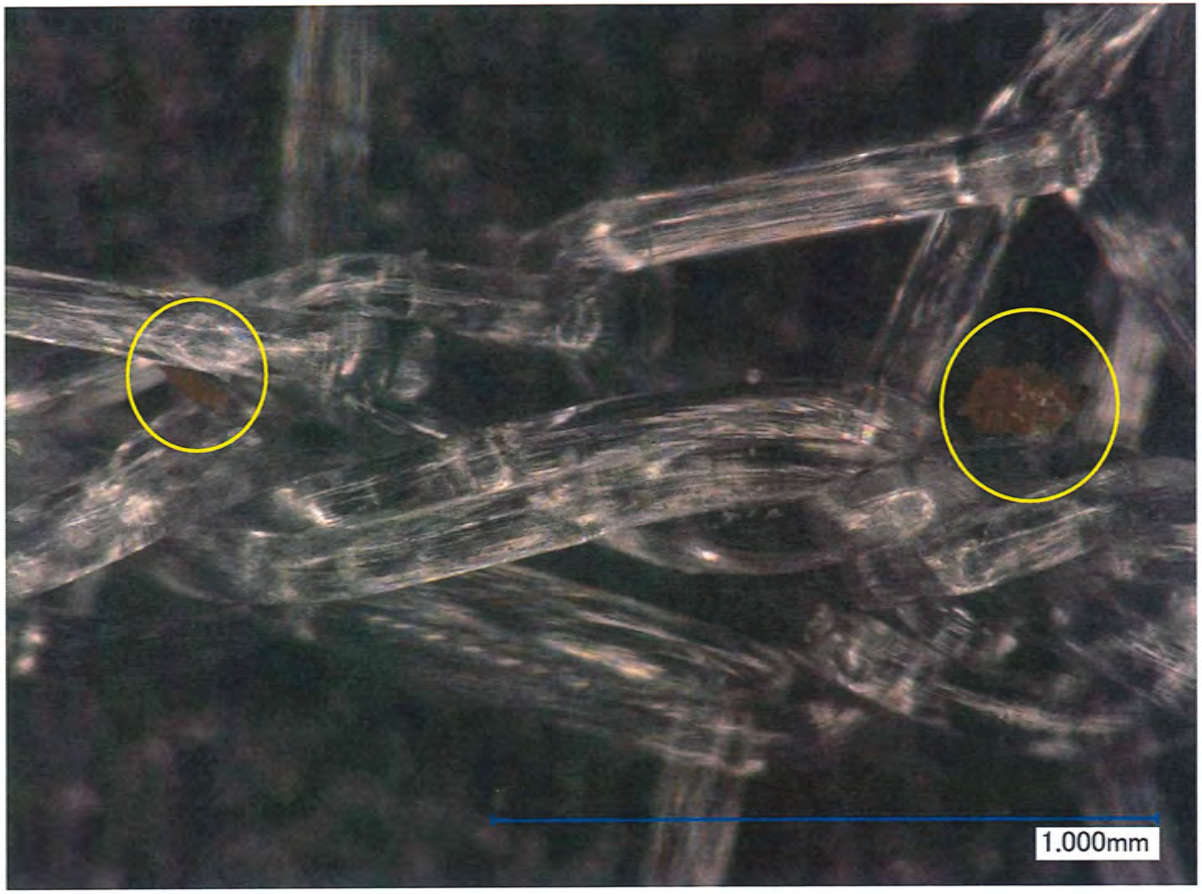
(Gynemesh PS)

Prosima filaments exhibit artefacts on the surface

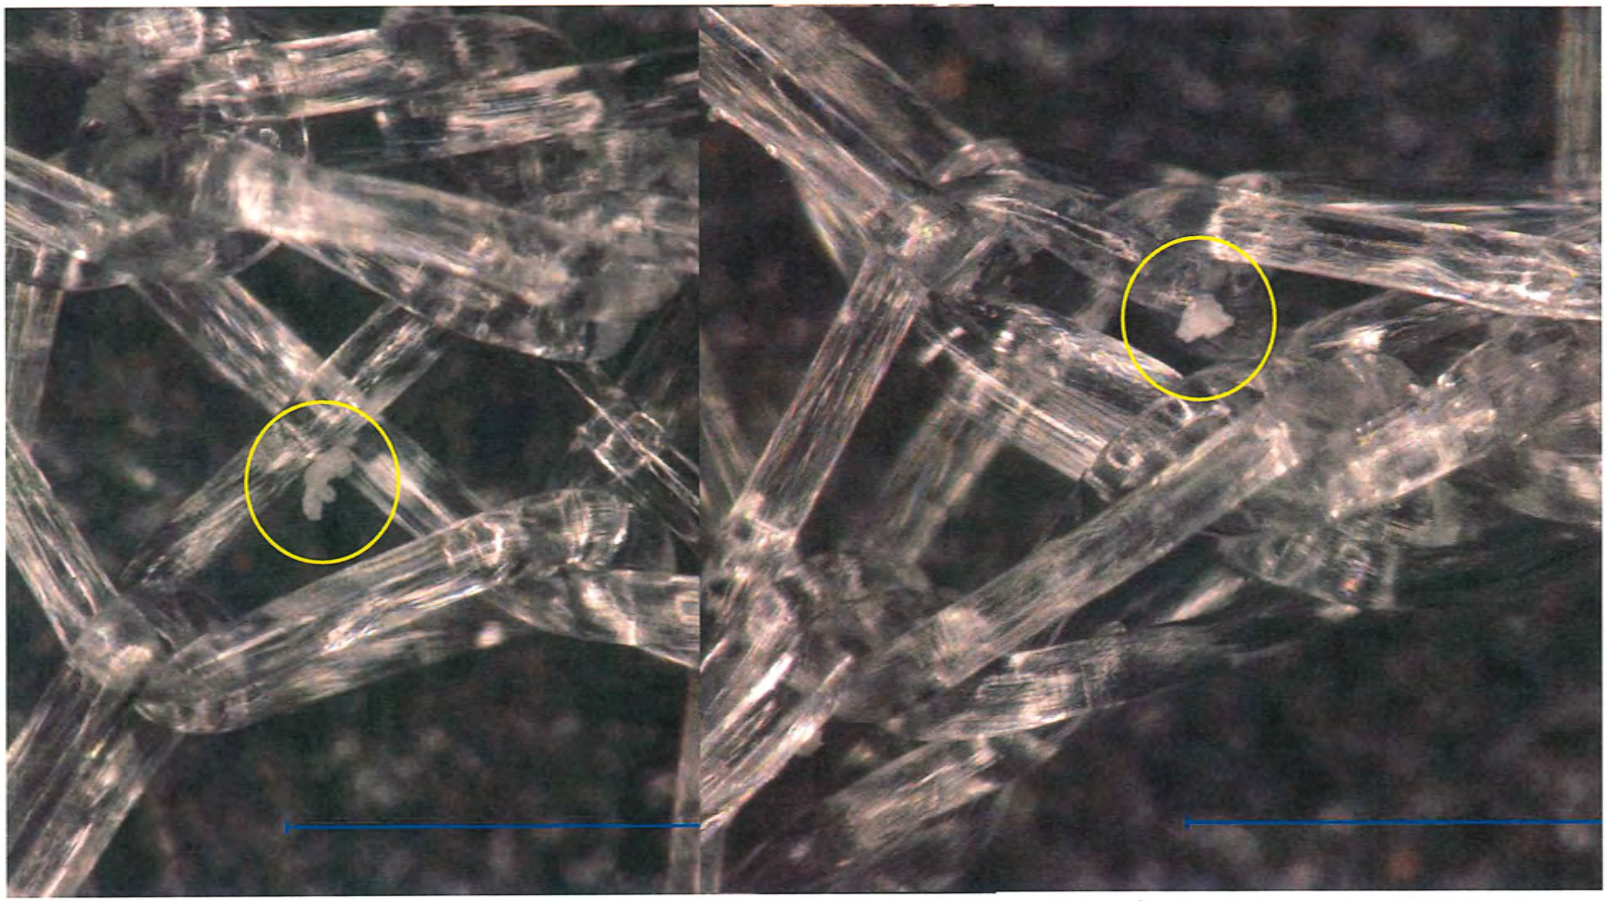
Prosima filaments exhibit artefacts on the surface (continued)

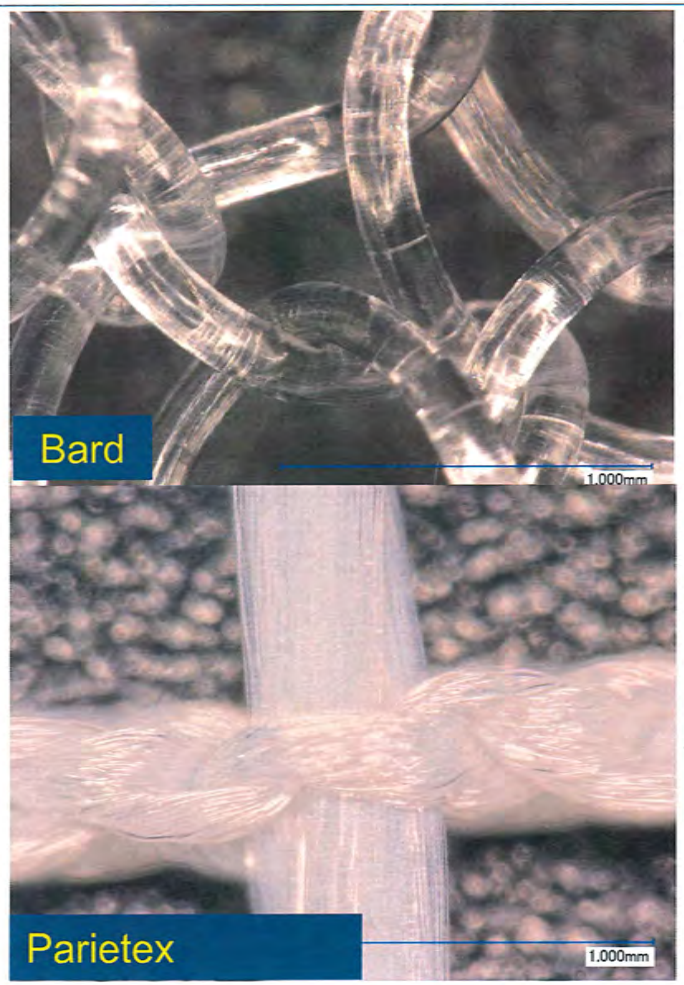
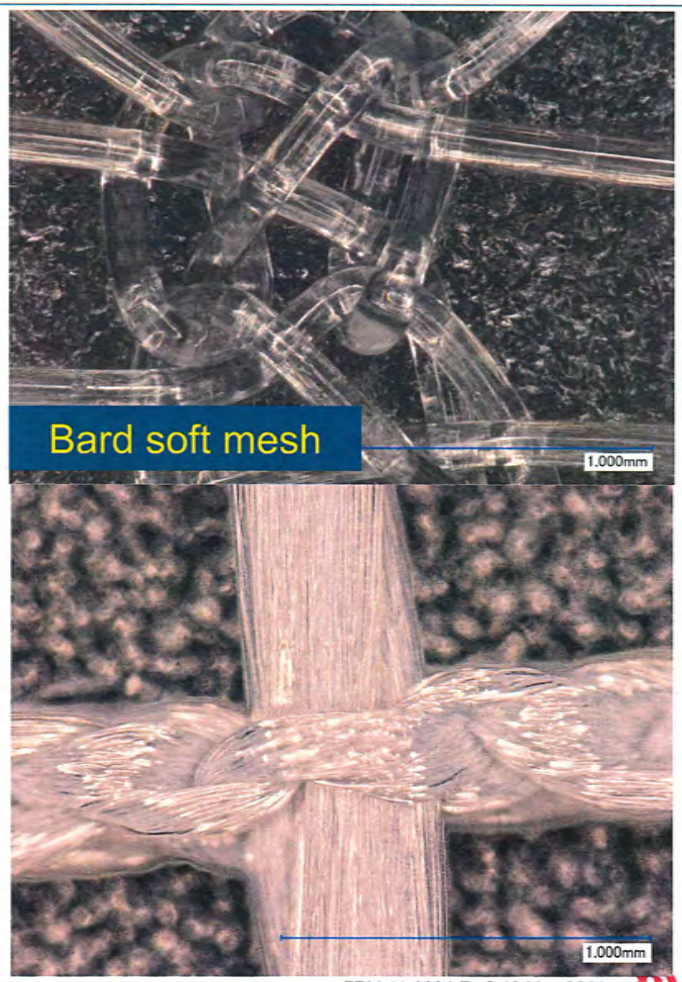
Competitor samples appear not to have the same artefacts – we scanned the filaments extensively

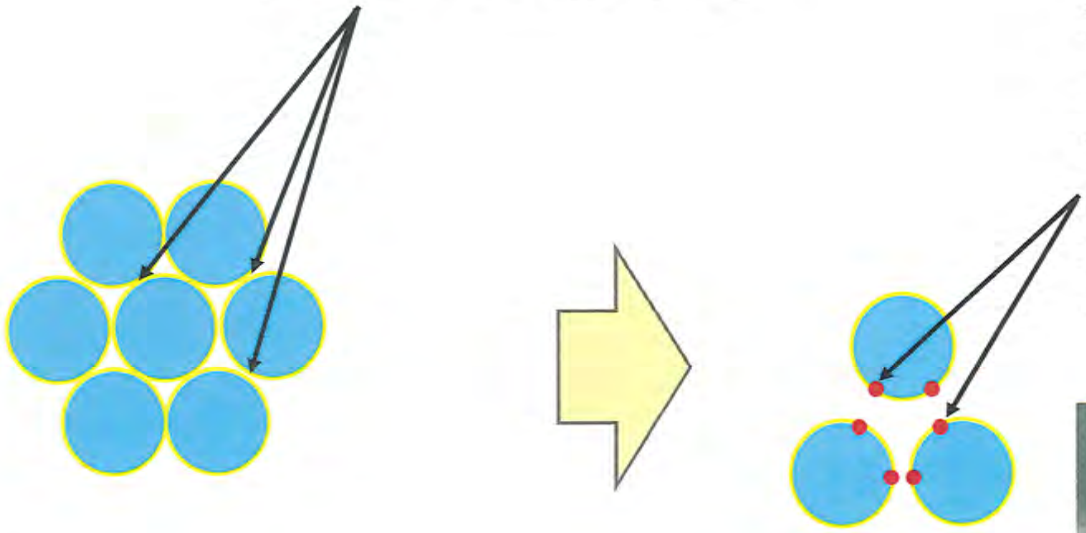
Points of contact along turns of continuous filament once wound up

If the filament has not fully cooled and 'set' prior to winding, it may be 'tacky' in places.

Hence when it is wound up, it will essentially adhere to itself forming 'bridges' between strands

Upon unwinding the bridges snap, material is either removed or deposited at the points of contact.

Some of the artefacts seen may also arise from process variables; e.g. temperature effects at the extrusion die, water content of the polymer and the finish of the tool.

Others may be due to residual processing materials that have not been completely removed through scouring
